# Boothbay-Boothbay Harbor CSD Building Exploratory Committee

July 2022

LAVALLEE|BRENSINGER ARCHITECTS

# Project Time line: July 2022 Update

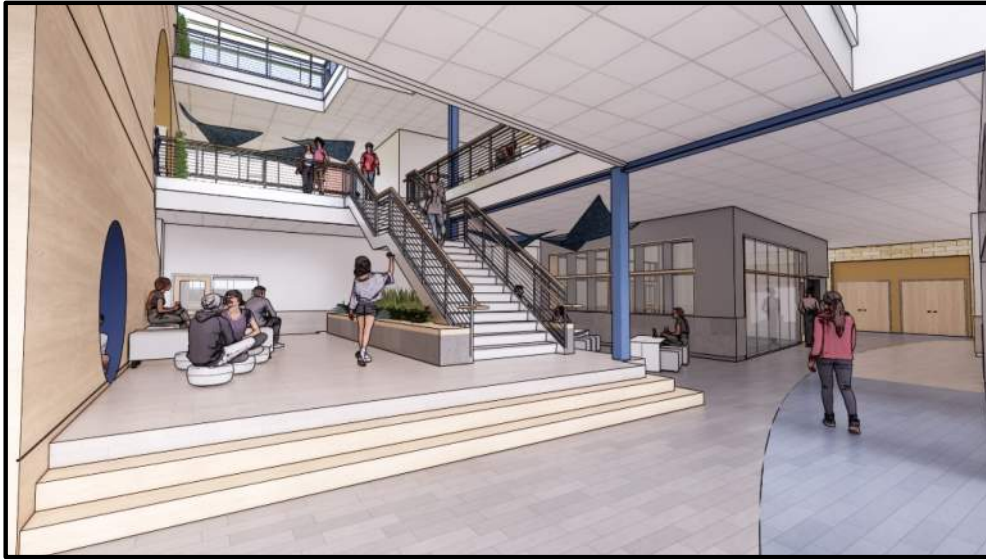
**View:** LVL 1 looking at the Social Stair

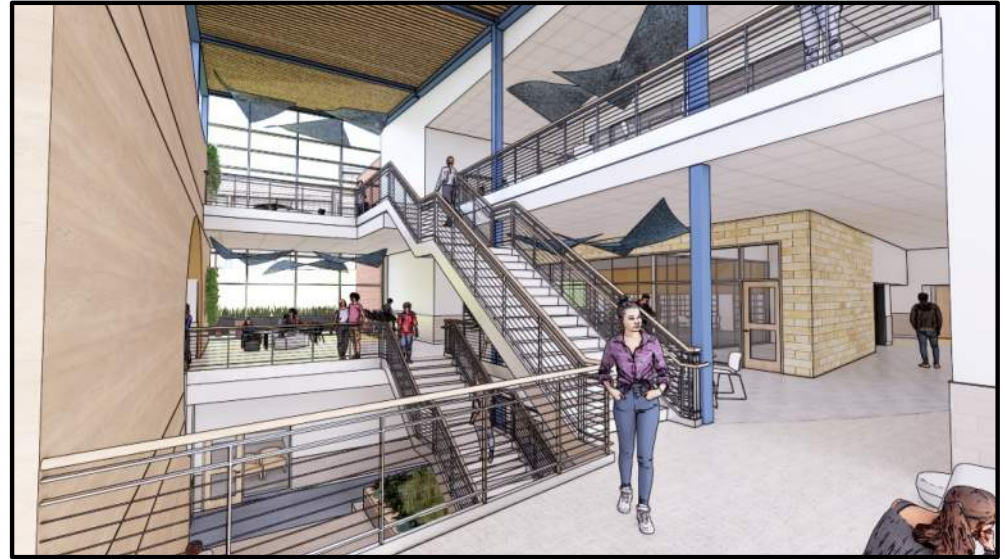
**View:** LVL 2 standing on the sky bridge looking towards the library

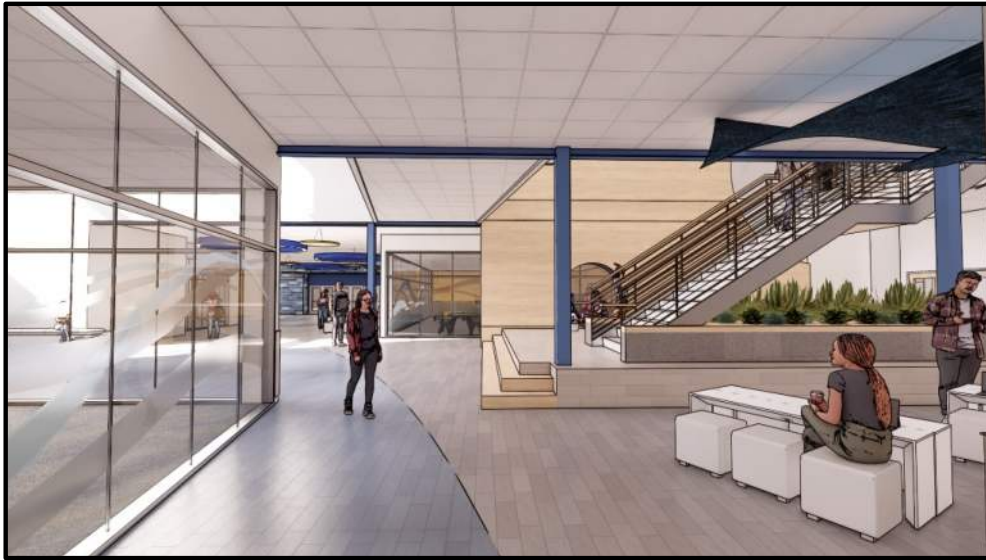
**View:** LVL 1 in front of main office looking towards the Social Stair

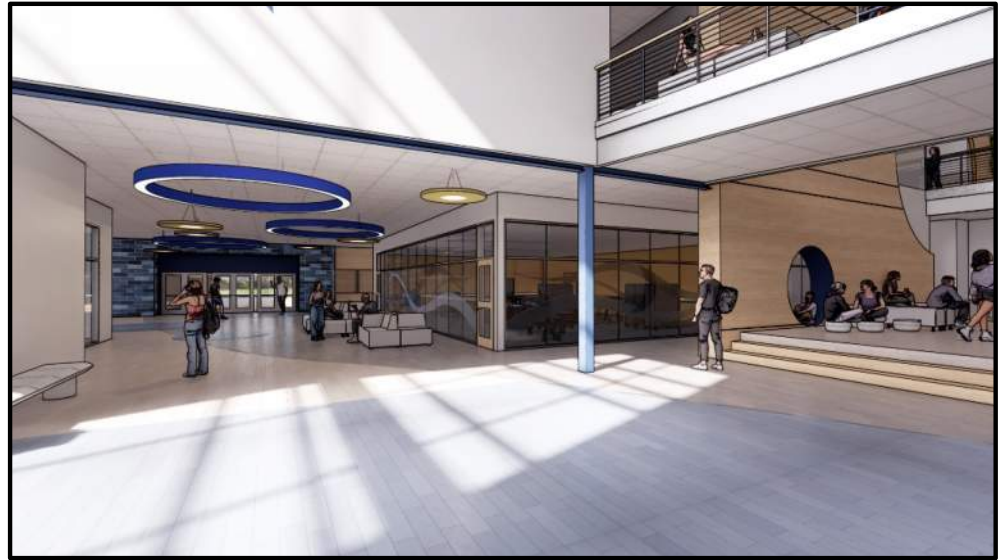
**View:** LVL 1 in front of main office looking towards the gym

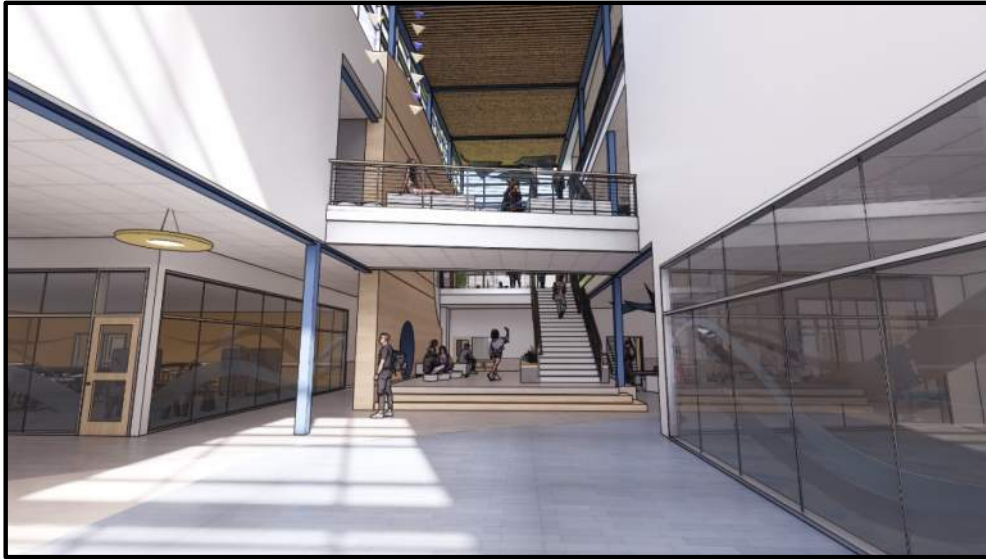
**View:** LVL 1 from the main entrance looking towards the social stair

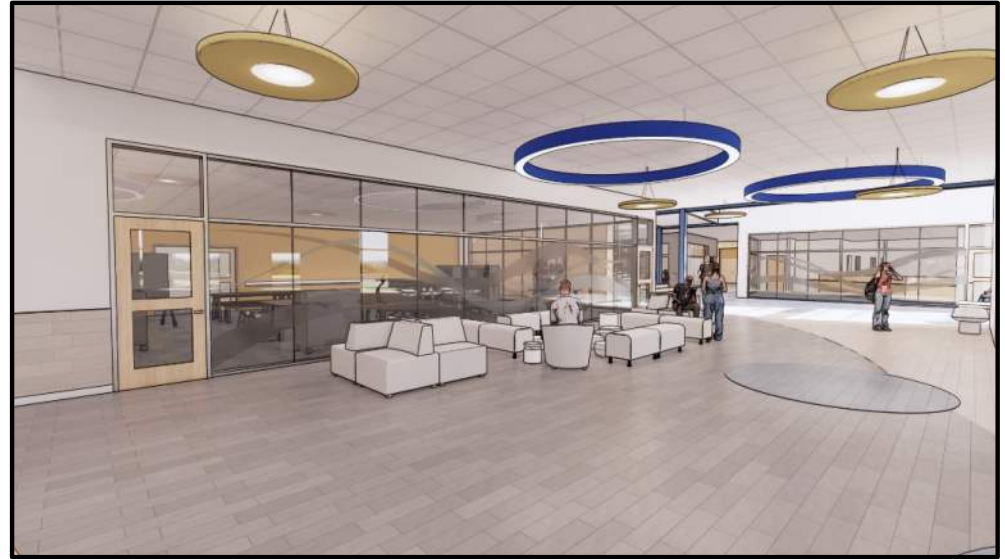
**View:** LVL 1 in front of the gym looking towards the maker space and the Social Stair

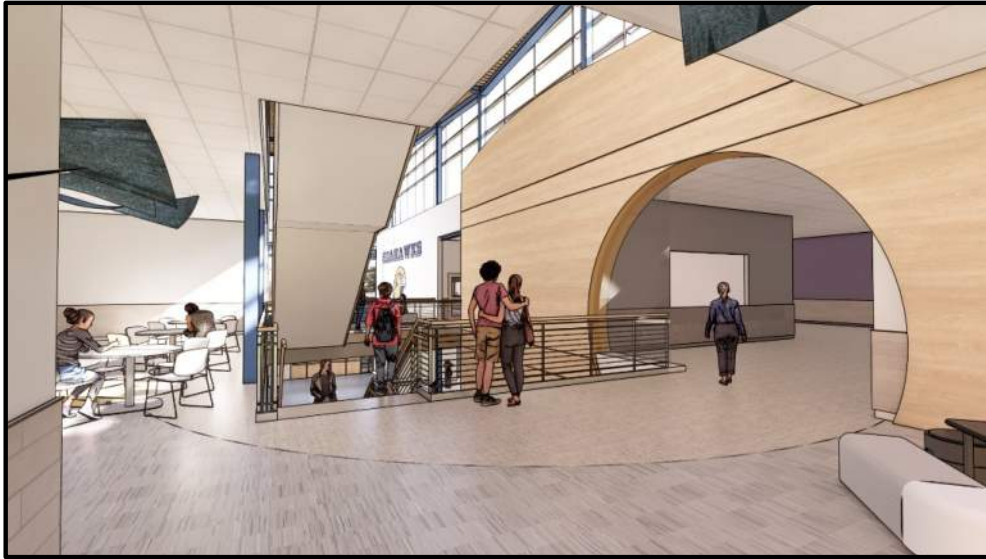
**View:** LVL 2 from the open gathering area looking towards the science wing and the Social Stair

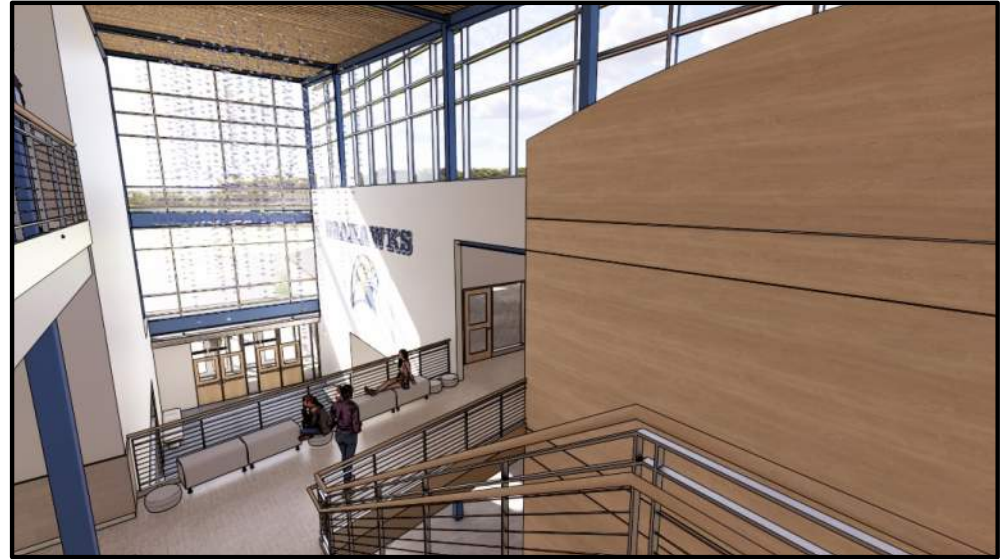
**View:** LVL 3 from the top of the Social Stair looking back towards the main entrance

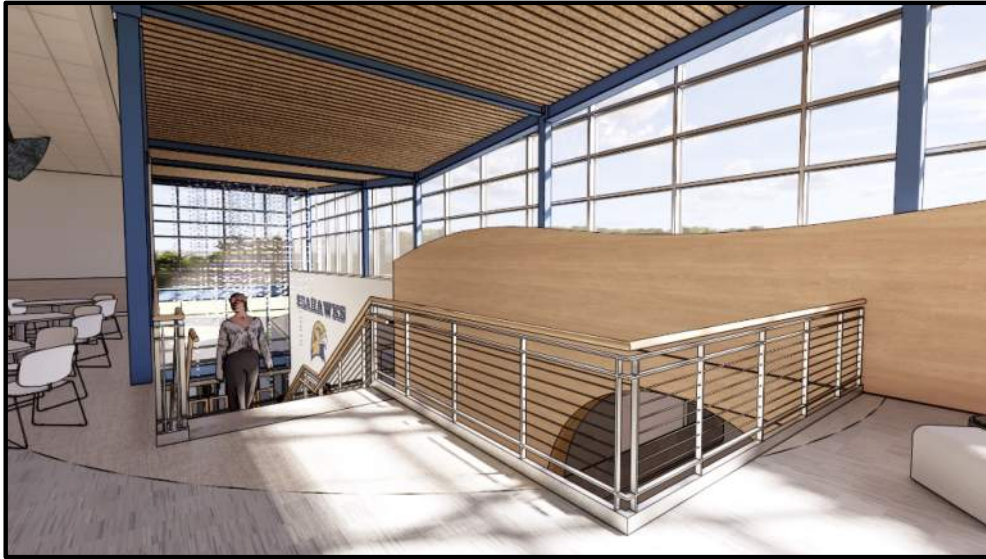
**View:** LVL 3 overlooking the Social Stair

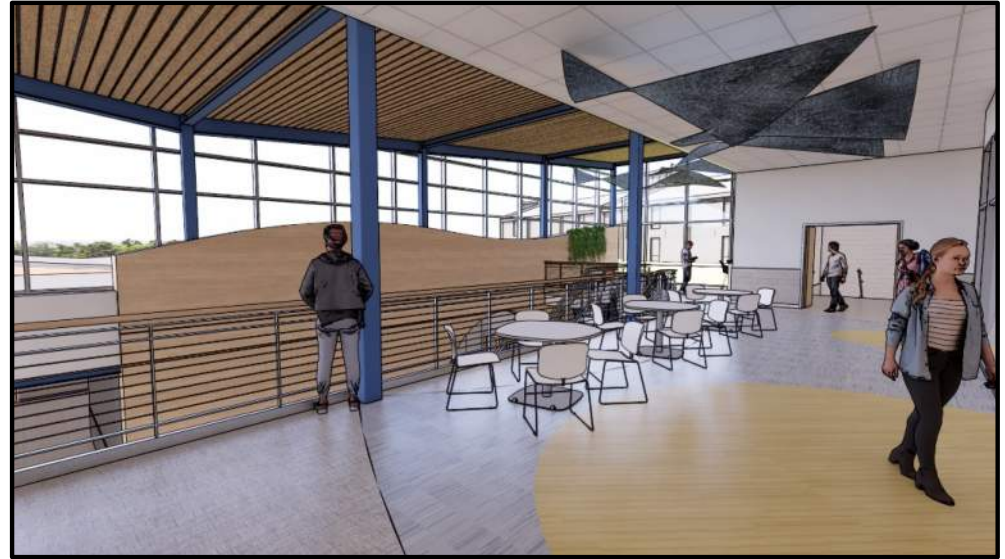
**View:** LVL 3 looking back towards some of the spill out seating from the dining commons
